Analysis of Vacuum-Brazed Joints of Glidcop®

F. DePaola¹, S. Sharma¹, I. C. Sheng², W. Toter³, K. Wilson¹

Abstract – Gold-copper (Au-Cu) brazing of Glidcop in hydrogen atmosphere has been widely used for the components of synchrotron light sources for many years. An evaluation of Au-Cu brazing of Glidcop without copper plating of the components was presented in [1]. Recently Glidcop vacuum components of two new light source facilities, NSLS-II (BNL) and TPS (NSRRC), have been brazed in vacuum atmosphere because the vacuum brazing process is more widely available and safer to use. These vacuum brazed joints were deemed to be successful based on visual examinations, micrographs of the joints, vacuum leak tightness, and preliminary tests for the bond strength.

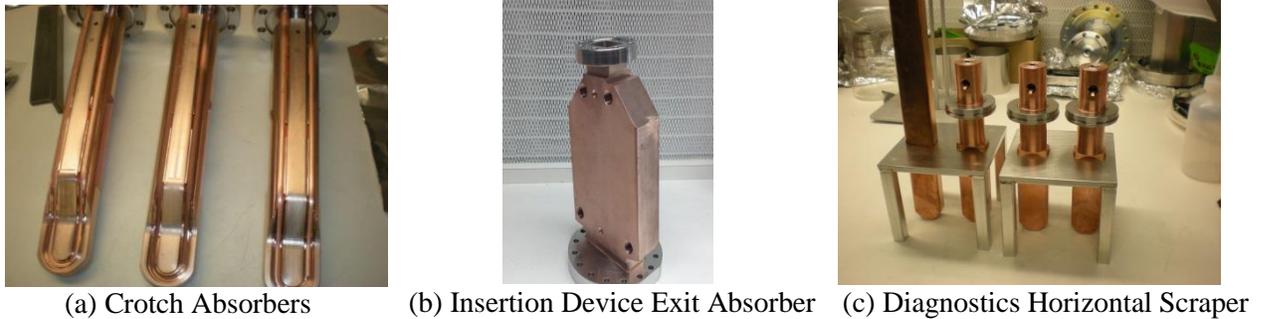
Figure 1: Vacuum brazed absorbers for the NSLS-II storage ring.

A large number of absorbers for the new NSLS-II storage ring were brazed in vacuum atmosphere (see Figure 1) and metallurgical testing procedures were performed to help characterize the quality of these vacuum brazed joints [2].

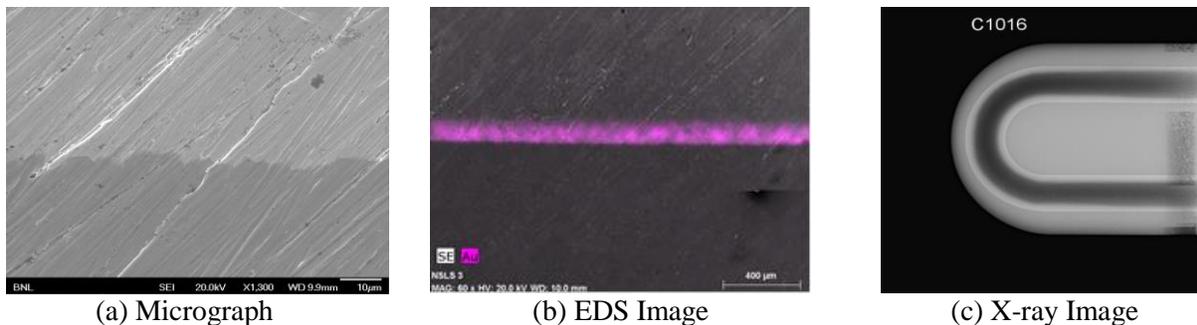
Figure 2: Inspection images of the vacuum brazed joints at NSLS-II, (a) micrograph of the 50/50 Au-Cu alloy to stainless steel 304L interface showing complete wetting and bonding, (b) energy dispersive spectroscopy image – chemical mapping of gold alloy at the braze interface, (c) an x-ray image of 50/50 Au-Cu braze joint between the OFC tube and Glidcop body of a crotch absorber.

The brazed joints were inspected using micrographs, energy dispersive spectroscopy (EDS) and x-ray radiographs (Figure 2). The joint interfaces show (a) complete wetting and bonding, (b) no significant diffusion of the braze alloy and (c) void free joints.

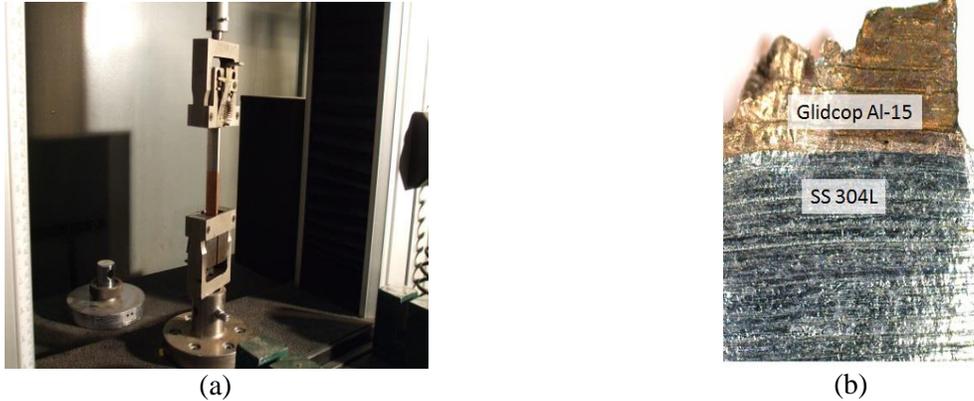
Figure 3: Tensile testing of a sample brazed at NSLS-II in vacuum atmosphere, (a) tensile test setup with sample having a cross section of 3 mm x 19 mm, (b) fracture in Glidcop Al-15 away from brazed joint.

A test sample having a cross section of 3 mm x 19 mm, was prepared to join Glidcop Al-15 to 304L stainless steel with 50/50 Au-Cu alloy in a vacuum atmosphere (Figure 3(a)). The specimen failed by fracture in Glidcop away from the braze interface while the brazed joint remained intact (Figure 3(b)). The applied load and stresses were not recorded during this test.

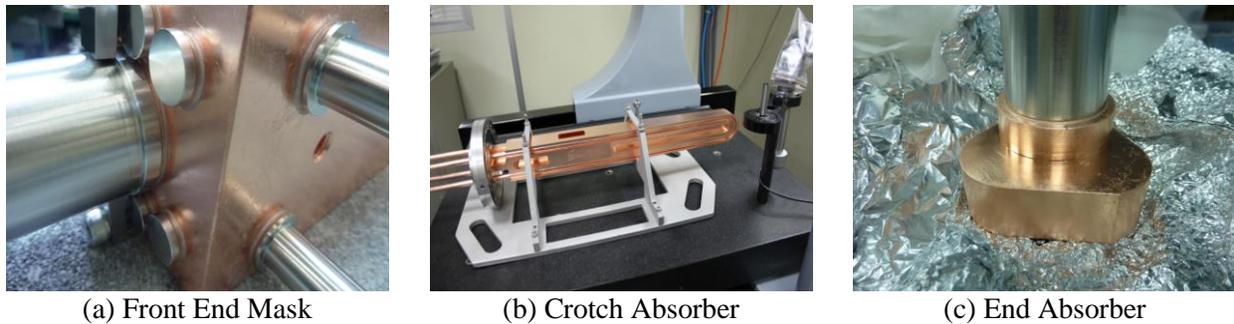
Figure 4: Vacuum brazed Glidcop components at the TPS storage ring, (a) front end mask with brazed aperture tube and water fittings, (b) crotch absorber in an inspection fixture, (c) end absorber used at the end of a straight vacuum chamber.

The study demonstrated that vacuum brazing was capable of producing good quality joints for UHV service as verified by helium leak testing and Scanning Electron Microscopy analysis. Figure 4 shows some examples of vacuum brazed components of the TPS storage ring.

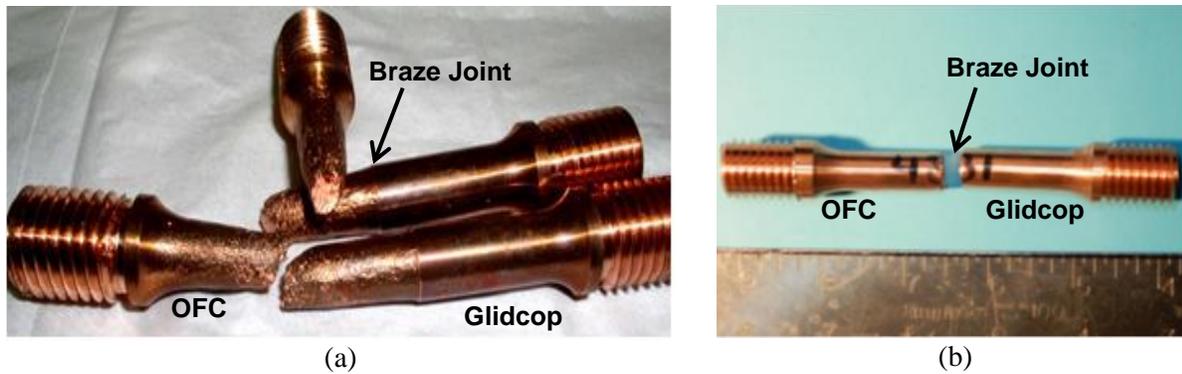
Figure 5: Glidcop Al-15 to OFC tensile test specimens brazed at ANL, (a) hydrogen brazed specimens failed in the OFC after significant necking [1], (b) separation at the vacuum brazed interface.

Four Glidcop to OFC samples were vacuum brazed then machined and tested per ASTM E8 standards. These tests showed that, unlike the specimens brazed in hydrogen atmosphere [1] which failed in the OFC after considerable necking (Figure 5(a)), the vacuum brazed specimen separated at the brazed joints without significant necking (Figure 5(b)).

The vacuum brazed specimens failed at stress levels that were significantly lower than those brazed in hydrogen atmosphere as shown in Table 1.

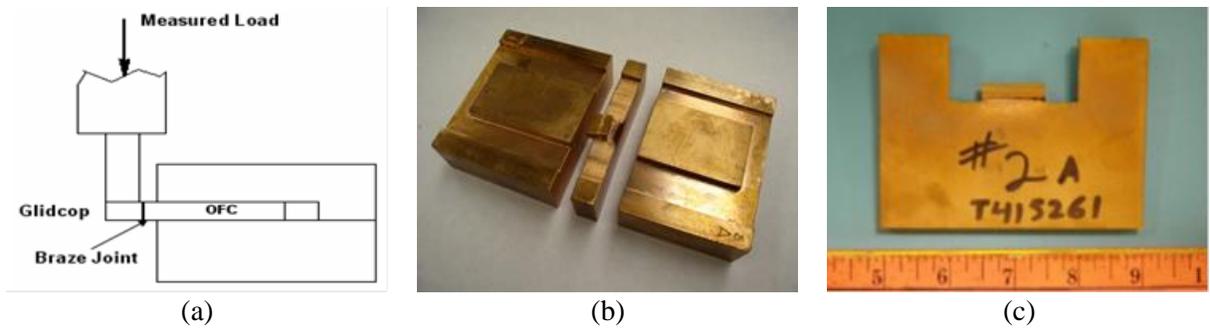
Figure 6: Shear strength tests on brazed joints between Glidcop to OFC, (a) shear test set up, (b), hydrogen-brazed sample with large deformation [1], and (c) brittle failure in a vacuum-brazed sample.

Four test samples were prepared to evaluate the shear strengths of joints between Glidcop Al-15 and OFC (C101 per ASTM F68) brazed with 0.1 mm thick 50/50 Au-Cu foils. The samples consisted of a 6.35 x 25.4 mm Glidcop plate brazed to a 76.2 x 101.6 mm OFC block. The test setup is shown in Figure 6(a). In the previous study of hydrogen-brazed joints [1], the testing was stopped when the stress hit 6000 psi due to deformation in OFC material (Figure 6(b)). In contrast, the vacuum-brazed joints showed brittle failure (Figure 6(c)) with shear strength in the range of 5,018 - 6,608 psi.

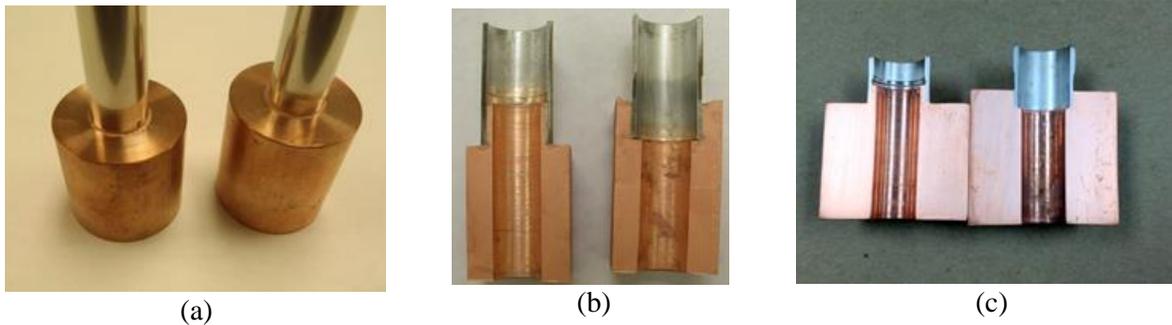
Figure 7: Braze joints between 304 stainless steel tubes of 19 mm diameter with a 1.65 mm wall thickness to Glidcop Al-15, (a) test specimens, (b) joints brazed in hydrogen atmosphere [1], and (c) joints brazed in vacuum atmosphere.

Stainless steel (304 per ASTM A213) tubes of 19 mm diameter with a 1.65 mm wall thickness were vacuum brazed to Glidcop Al-15 (Figure 7(a)) with 50/50 Au-Cu alloy in inner and outer joint configurations. The brazed joints passed visual inspection and vacuum leak tests, MSLD at 1×10^{-9} cc/sec sensitivity. The sectioned brazed joints showed good joint quality (absence of porosity and lack of alloy diffusion) comparable to those brazed in hydrogen atmosphere (Figures 7(b) and 7(c)).

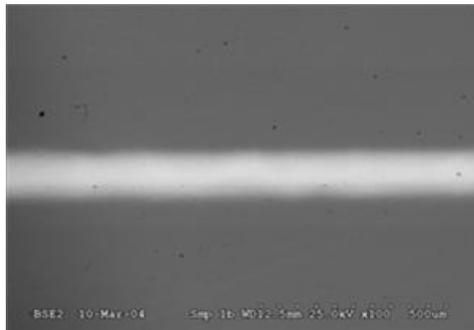
(a) 2003 – Low Power SEM as brazed

Figure 8: SEM analysis of the hydrogen brazed samples (a) the as brazed joints were sound. (b) slight amount of internal voids showed after the second braze cycle. Optical microscopy was performed on the vacuum brazed samples (c) the as brazed joints were not 100% sound. (d) this section taken after a second braze cycle revealed a lack of bond that most likely existed from the original braze cycle. A slight amount of internal voids were observed (not shown) and there was some gold attack on the copper base material.

Scanning electron microscopy analysis was performed on the hydrogen brazed joints of the shear samples to demonstrate the bond quality of the as brazed joint (Figure 8(a)) and to quantify the effect of the second brazing cycle (Figure 8(b)). Samples were taken from sound portions of the brazed joints.

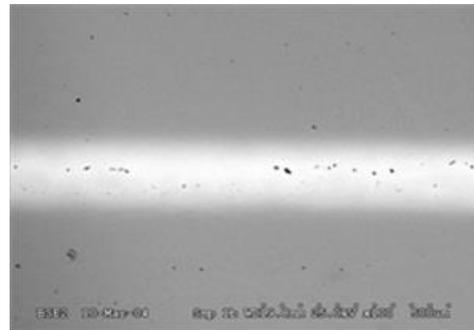
(b) 2003 – Low Power SEM re-brazed (2 cycles)

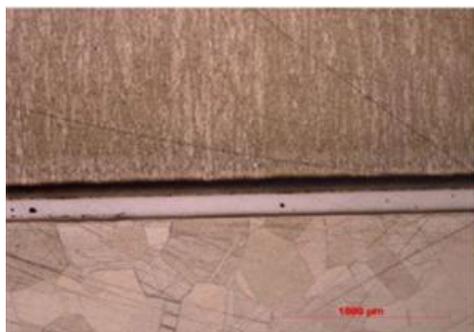
(c) 2014 – Photomicrograph as brazed

Optical microscopy was performed on the vacuum brazed joints of the shear samples to demonstrate the bond quality of the as brazed joint (Figure 8(c)) and a second sample which was exposed to two brazing cycles (Figure 8(d)). Results of the optical microscopy revealed that there were several areas where lack

of bond existed between the filler and copper base material. However where the bond existed, the bonded area was good. There was some slight attack of the Au-Cu filler on the copper base material for samples exposed to a second braze cycle; however the integrity of the bond in those areas was acceptable.

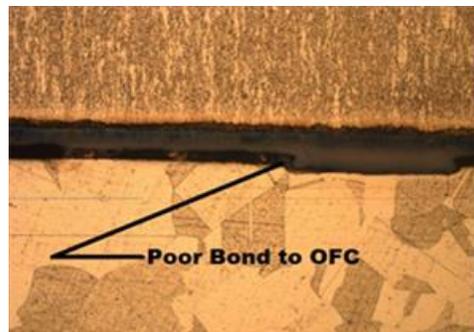
(d) 2014 – Photomicrograph re-brazed (2 cycles)
