# The Quest for Stability at NSLS-II

Andy Broadbent with acknowledgements to many staff at NSLS-II and especially Yong Chu (HXN beamline group leader) and Nick Simos (vibration engineer).

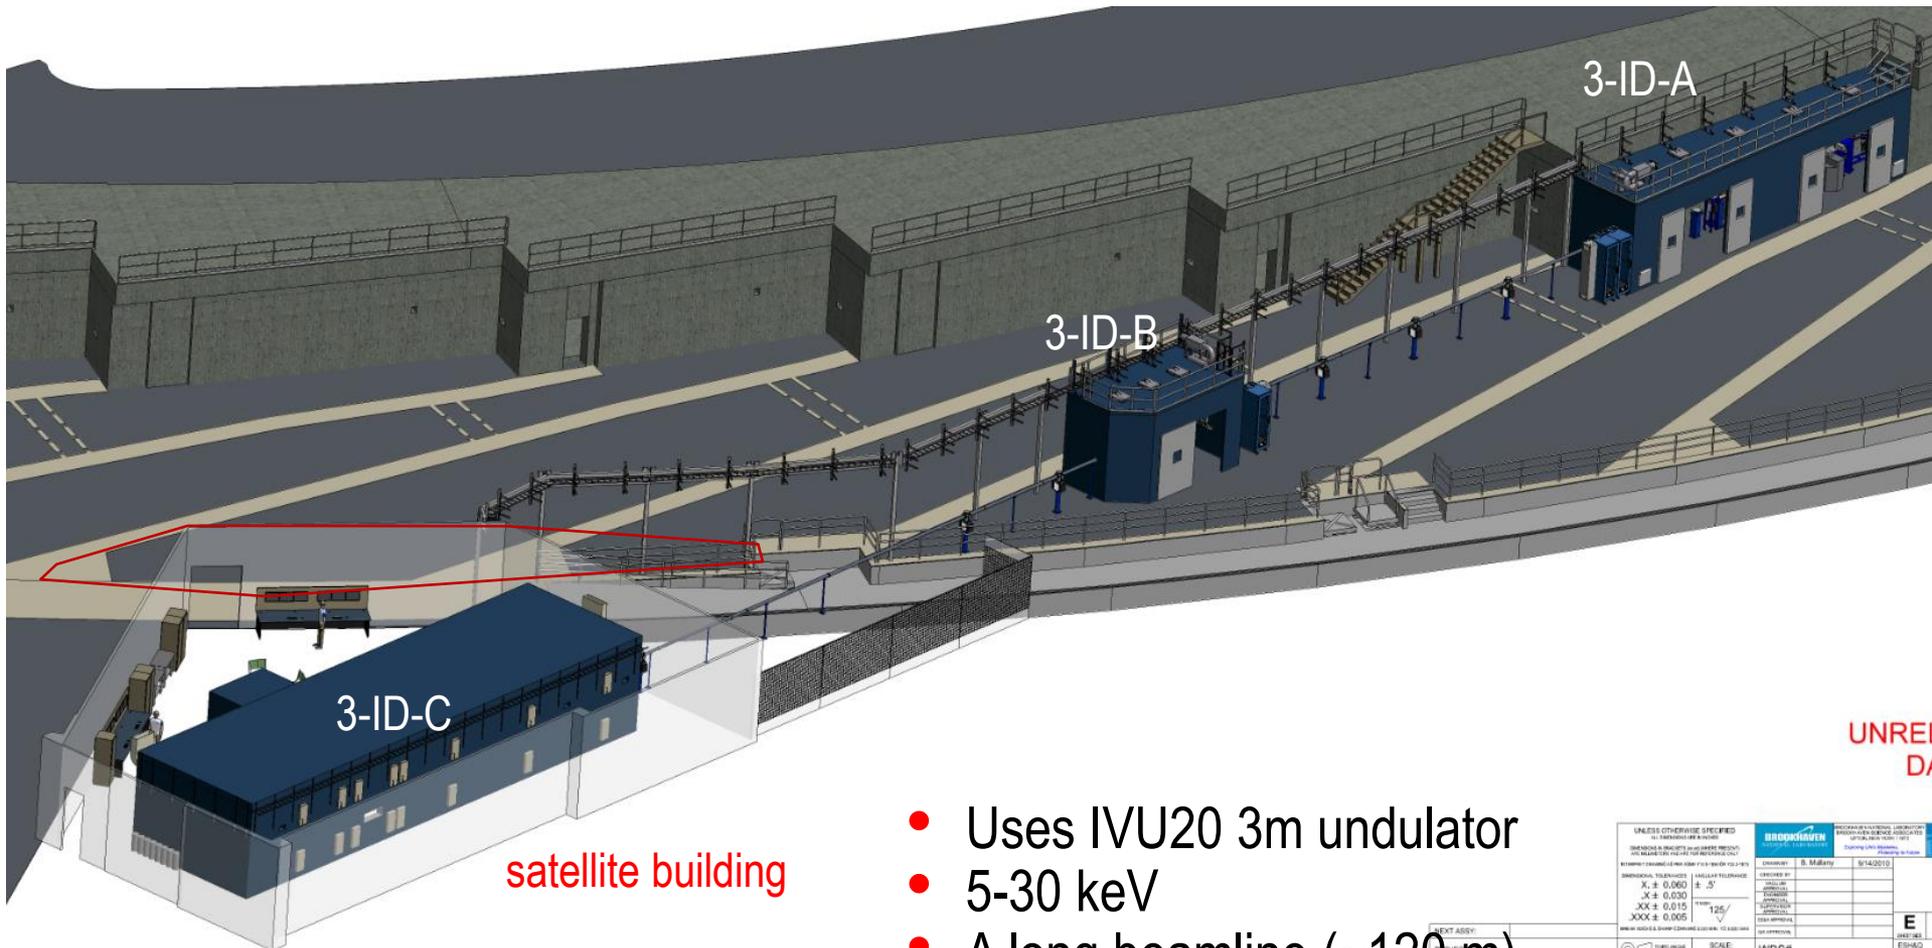
# Beamline Overview

- Uses IVU20 3m undulator
- 5-30 keV
- A long beamline (~120 m)
- 3 Stations (3-ID-C in the satellite building)
- Mono beam outside A-hutch

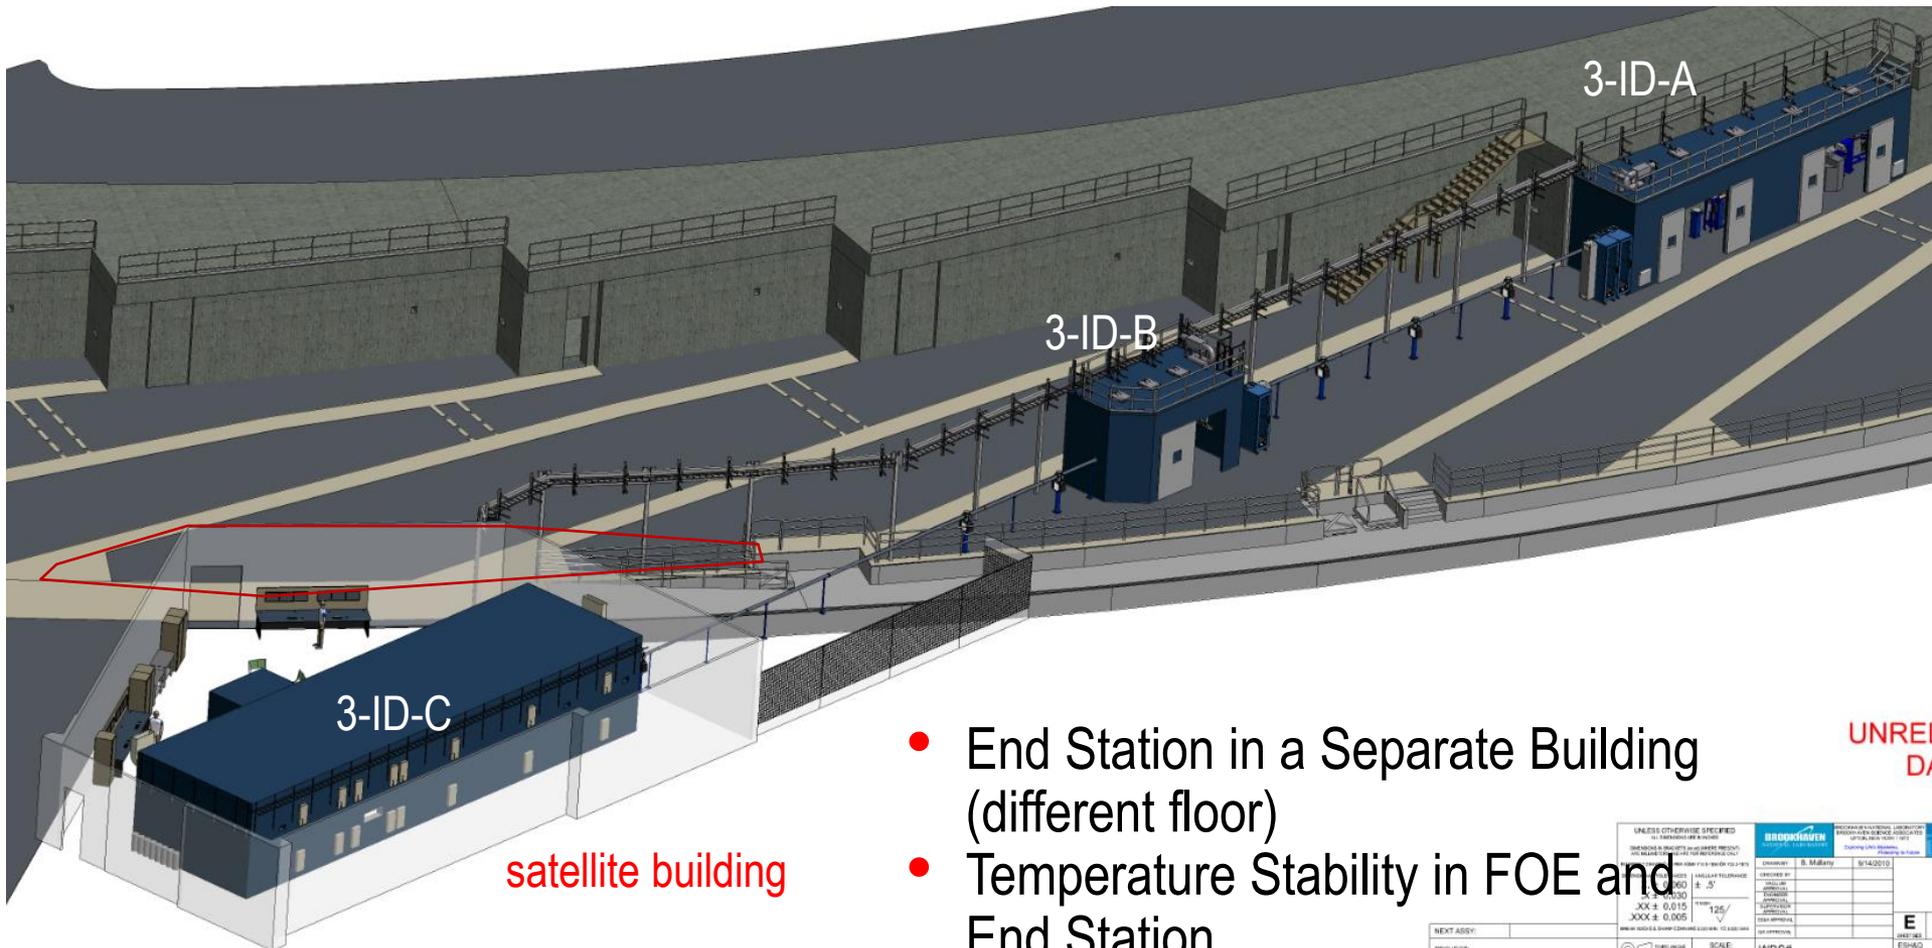
# Some Mechanical Challenges

- End Station in a Separate Building (different floor)
- Temperature Stability in FOE and End Station
- Vibrational Stability along full length of Beamline

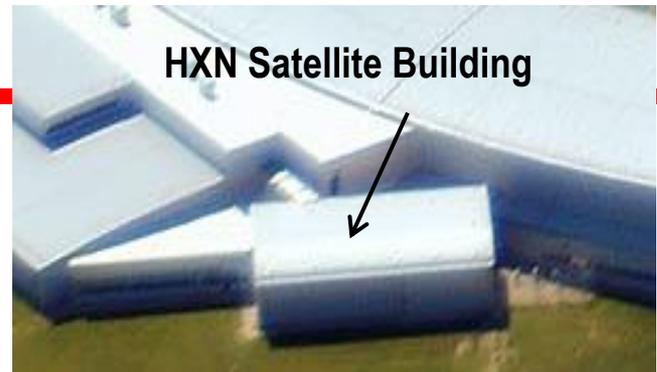
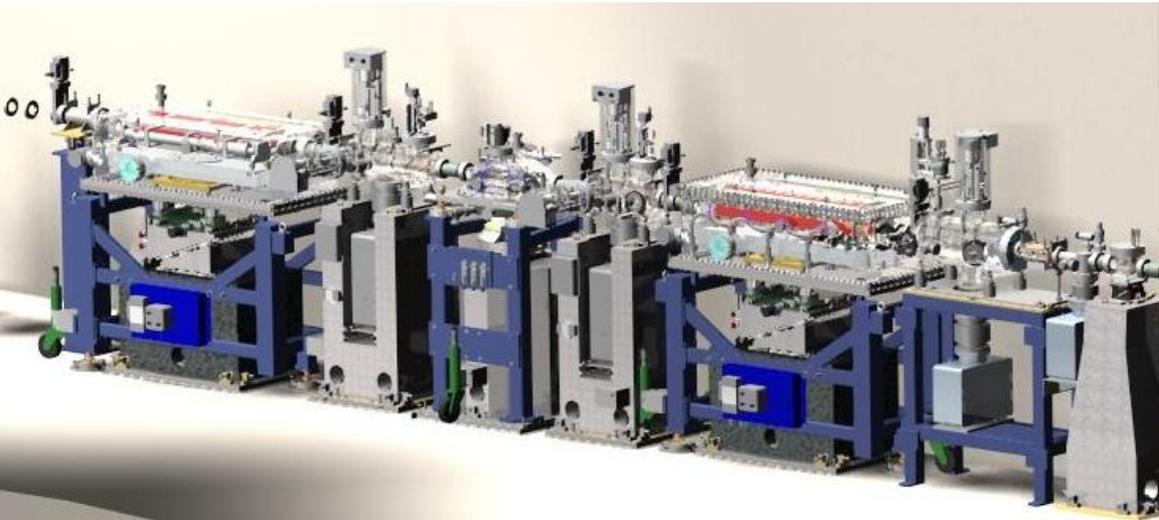
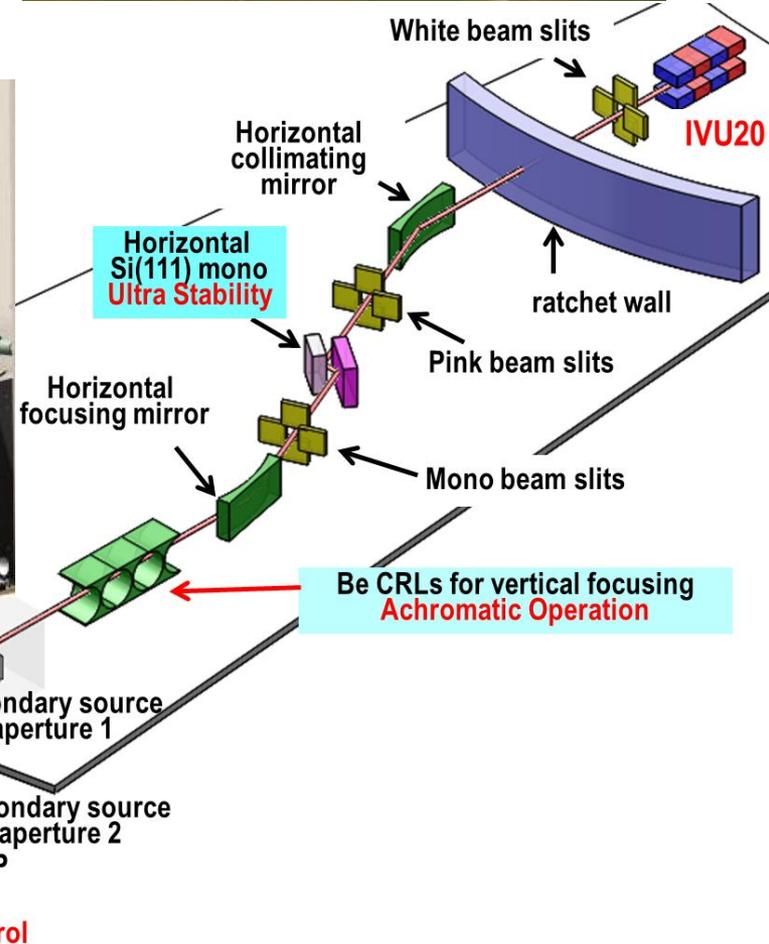
# Hard X-ray Nanoprobe Beamline

- ~110m-long beamline
- Satellite building for vib.& temp. stability
- Extremely stable 2D secondary source and stable beamline optics
- X-ray microscope w/ ~1nm positioning stability
- MLL and ZP optics
- In-situ sample environments

BL energy: 6-25 keV

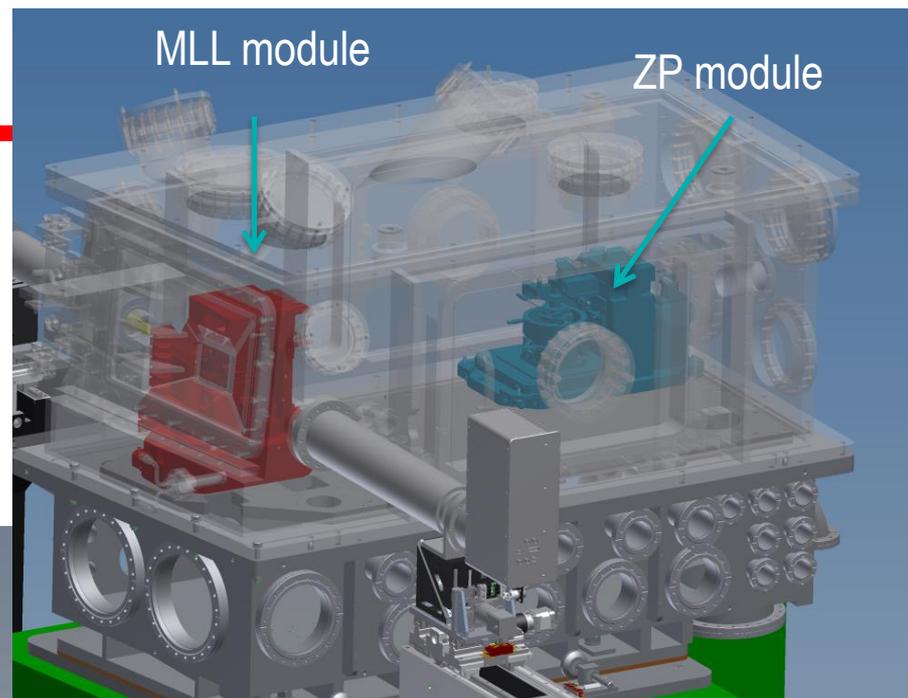
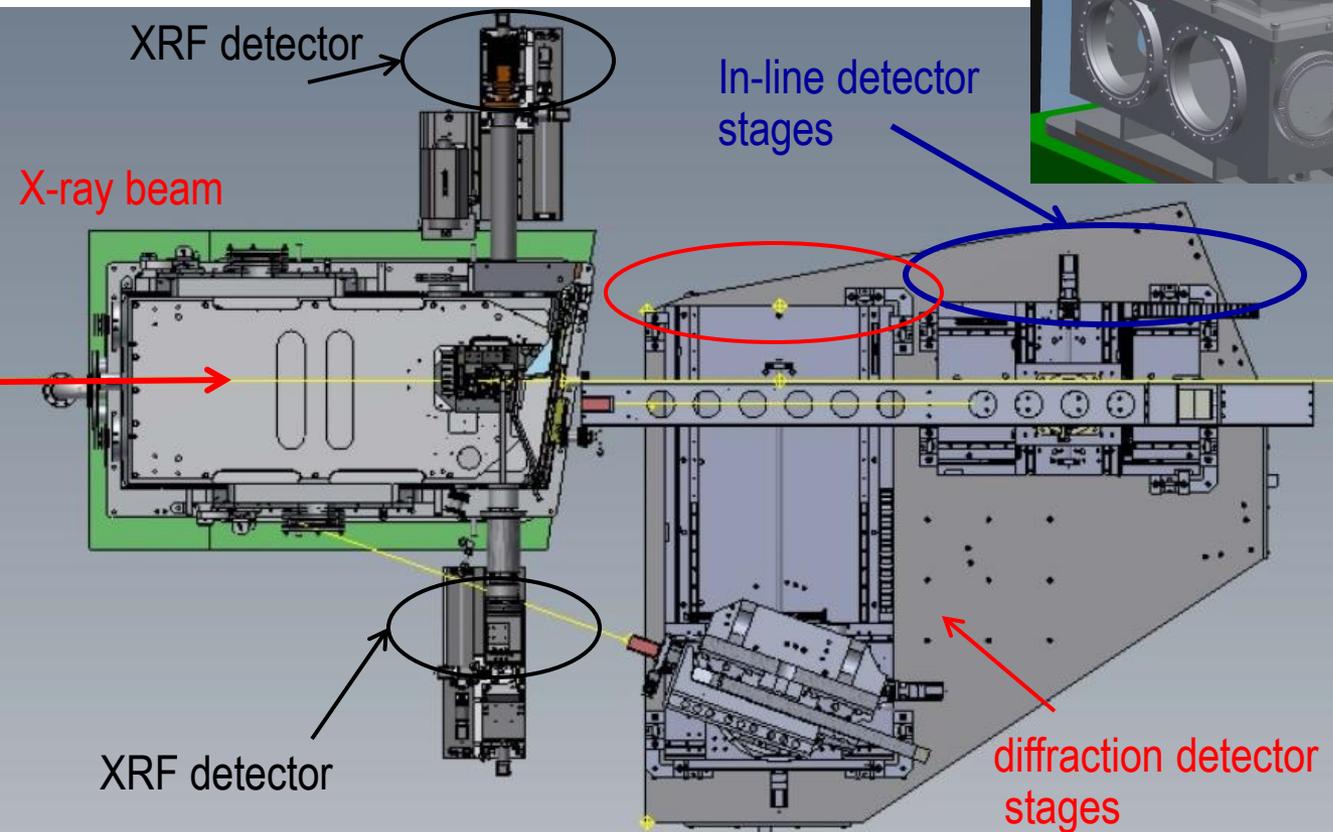
# HXN X-ray Microscope

- 10 nm resolution for fluorescence & diffraction
- phase contrast imaging & ptychography
- MLL and ZP modules, hot-swappable
- sub-1 nm stability w/ laser interferometers
- In-vacuum system
- In-situ sample temperature regulation

Developed over 4 years:  
NSLS-II R&D and collaboration  
with Deming Shu (APS)

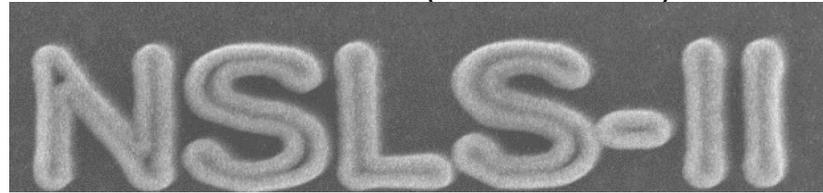
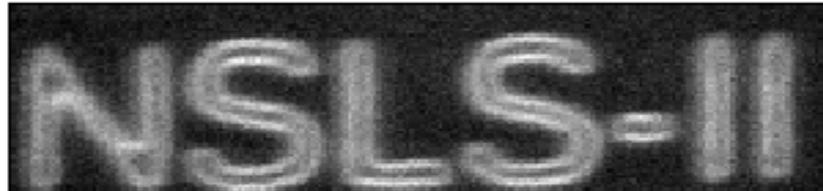
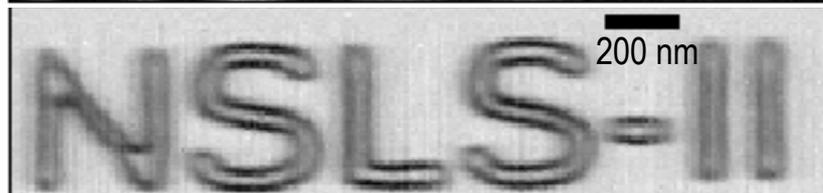
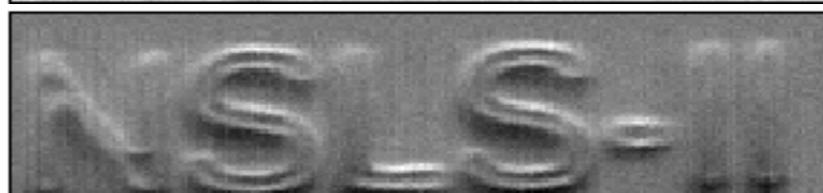
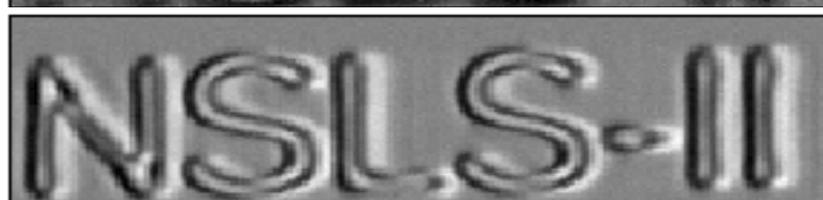
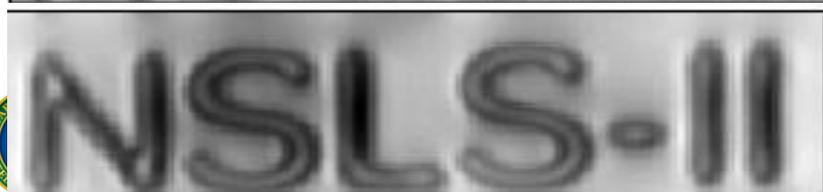
# X-ray Performance

Focus achieved at 11.8 keV (at Diamond):

- 19 nm (horiz) x 41 nm (vertical) by knife edge scan
- 13.3 nm (horz) x 30.1 nm (vertical) by ptychography

Instrument stability: < 4nm/hr, analysis in progress

SEM

Pt XRF

Absorption

Vertical  
Phase Contrast

Horizontal  
Phase Contrast

Analyzed  
Phase

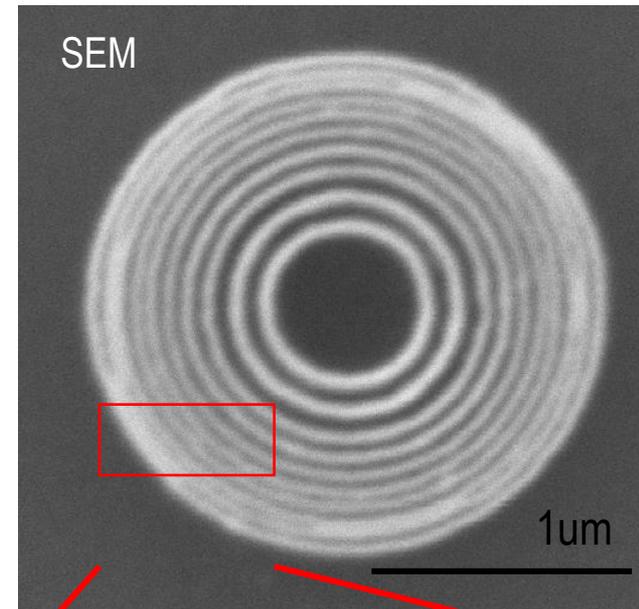
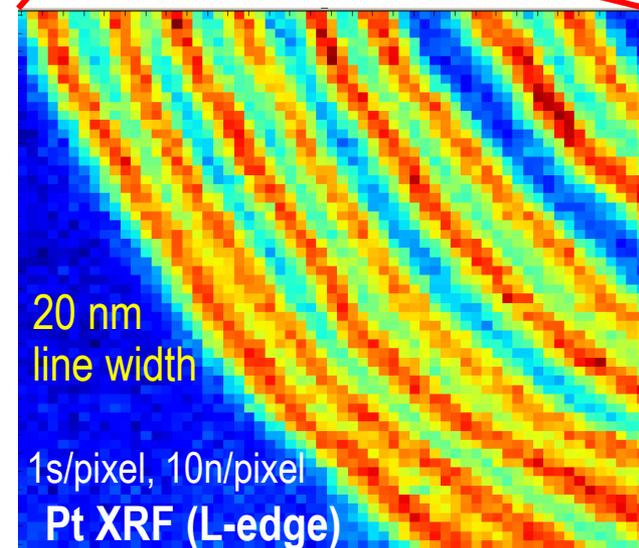
SEM

20 nm  
line width

1s/pixel, 10n/pixel  
Pt XRF (L-edge)

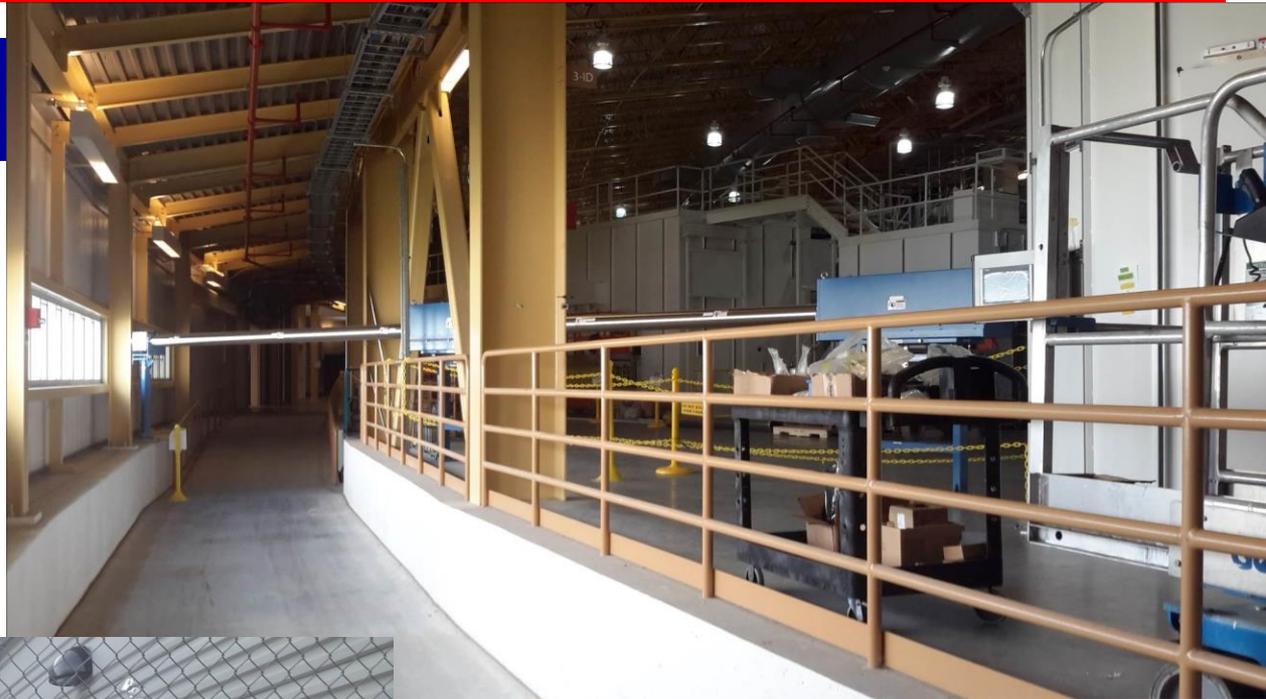
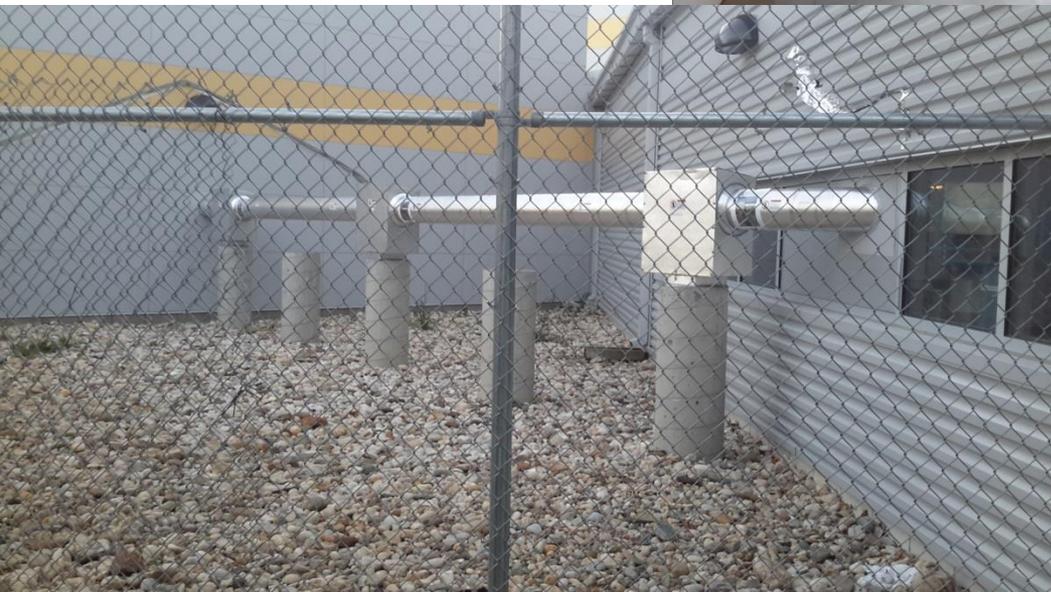
# Long Transport Pipe to Satellite Building

Crosses sunken bypass corridor  
at building perimeter

Pipe then goes outdoors and is carefully  
protected against the weather and deer.

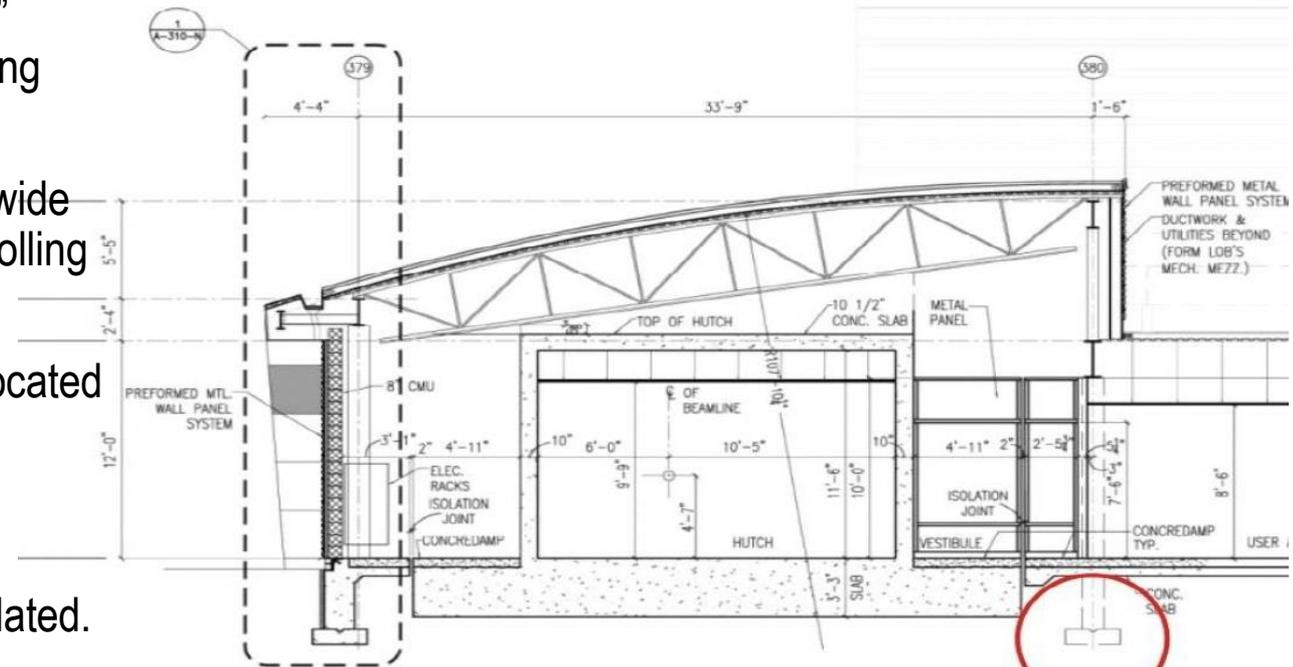
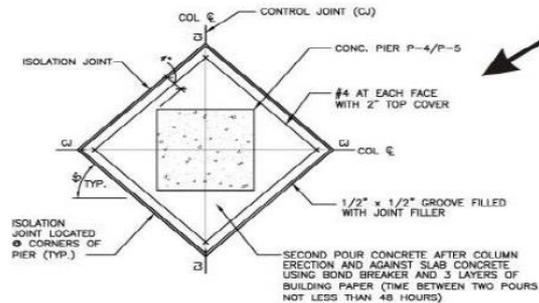
# End Station: Structural Design Considerations

- Careful attention to vibration modelling – many configurations evaluated
- Opted for separate “building” adjacent to Lab Office Building with:

- 1m thick floor with wide “flange” to reduce rolling mode.
- HVAC equipment located in LOB not satellite building.
- Walls and roof are extremely well insulated.
- Concrete hutch gives thermal mass and increases torsional rigidity.

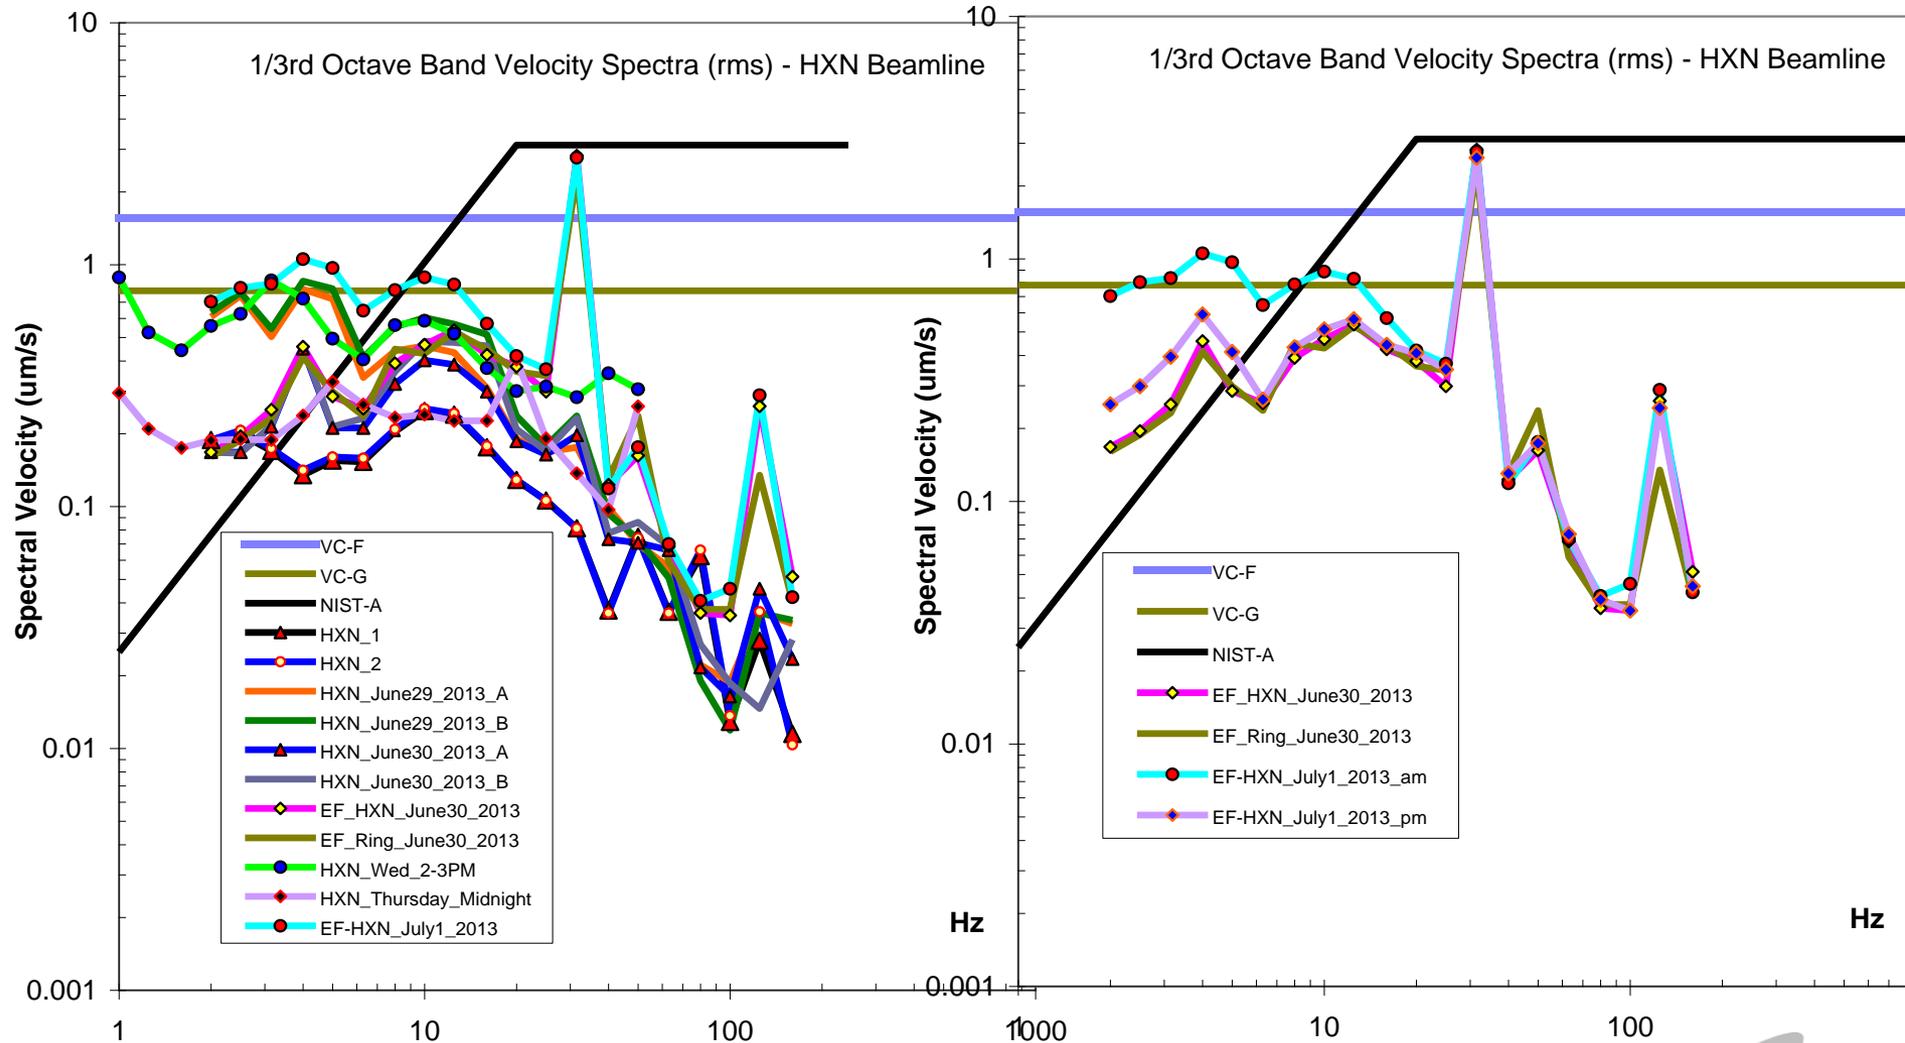
# Vibration Data for HXN End Station and NSLS-II Floor

HXN Stability Summary - October 2013

Extensive Measurements have been performed on the HXN Endstation Floor and the Experimental Floor Vicinity addressing both the PRIMARY Wide Band Criteria (1/3<sup>rd</sup> Octave Velocity and V-C criteria) and the Narrow Band Criteria (secondary for the HXN)

**THE PRIMARY CRITERIA on the HXN (i.e. the wide band VC-based criteria VC-E, and also the VC-F criteria ARE SATISFIED. At off peak periods even the VC-G criteria of 0.78  $\mu\text{m/s}$  spectra in 1/3<sup>rd</sup> octave band are satisfied.**

The narrow band criteria of  $\leq 25 \text{ nm}$  for  $>4 \text{ Hz}$  appear to be exceeded at periods during the day time when local traffic, the LIE and the Chilled Water Facility are on.

**Generally the measurements agree with the modelled data quite well.**

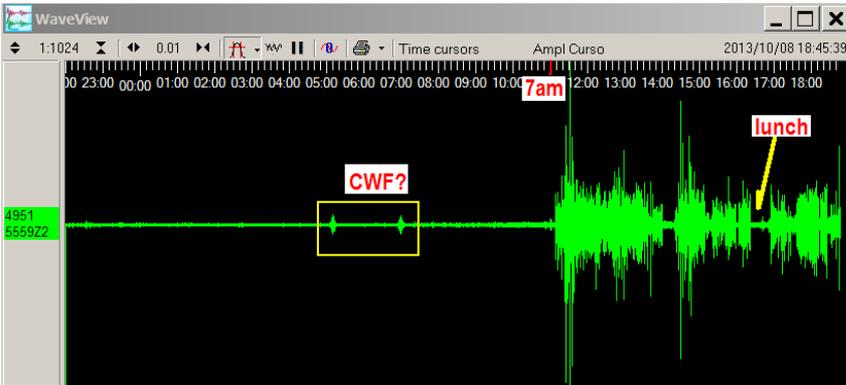
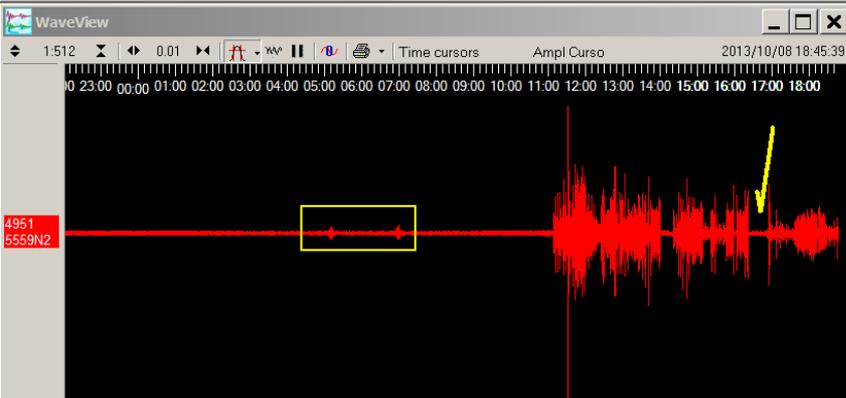
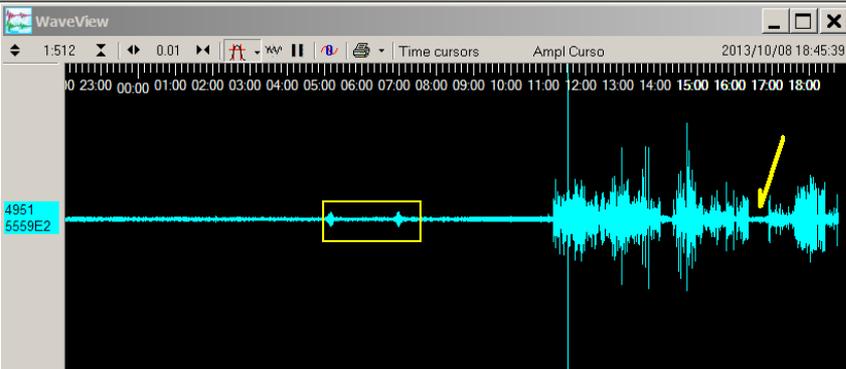
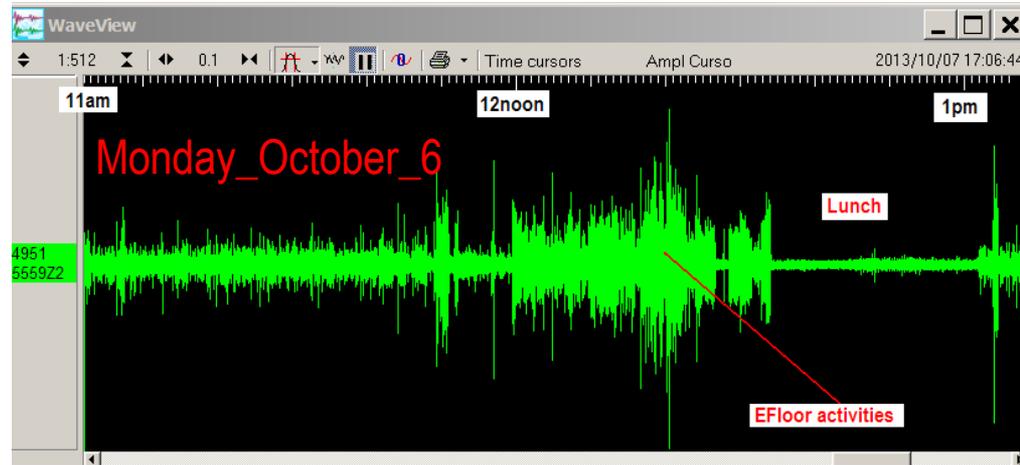
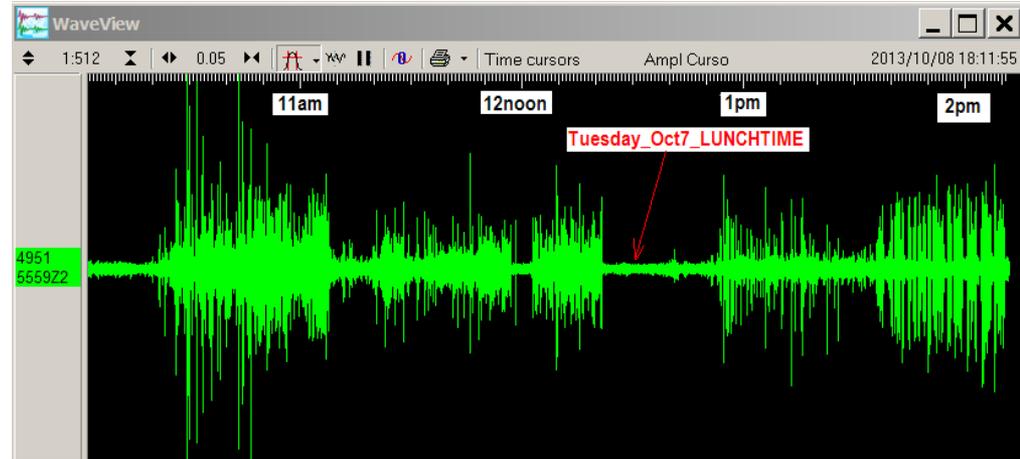
# Vibration Data over 24 hours

Considerable local construction activity ongoing 7am – 6:30pm, with break for lunch!

Attempt to capture different conditions that effect the HXN floor vibration was made (i.e. quietest times over the weekend vs. most active times with heavy installation work on the experimental floor). Because of this continuing INSTALLATION work on the floor, it is still hard to establish the operating environment conditions especially those during the day.

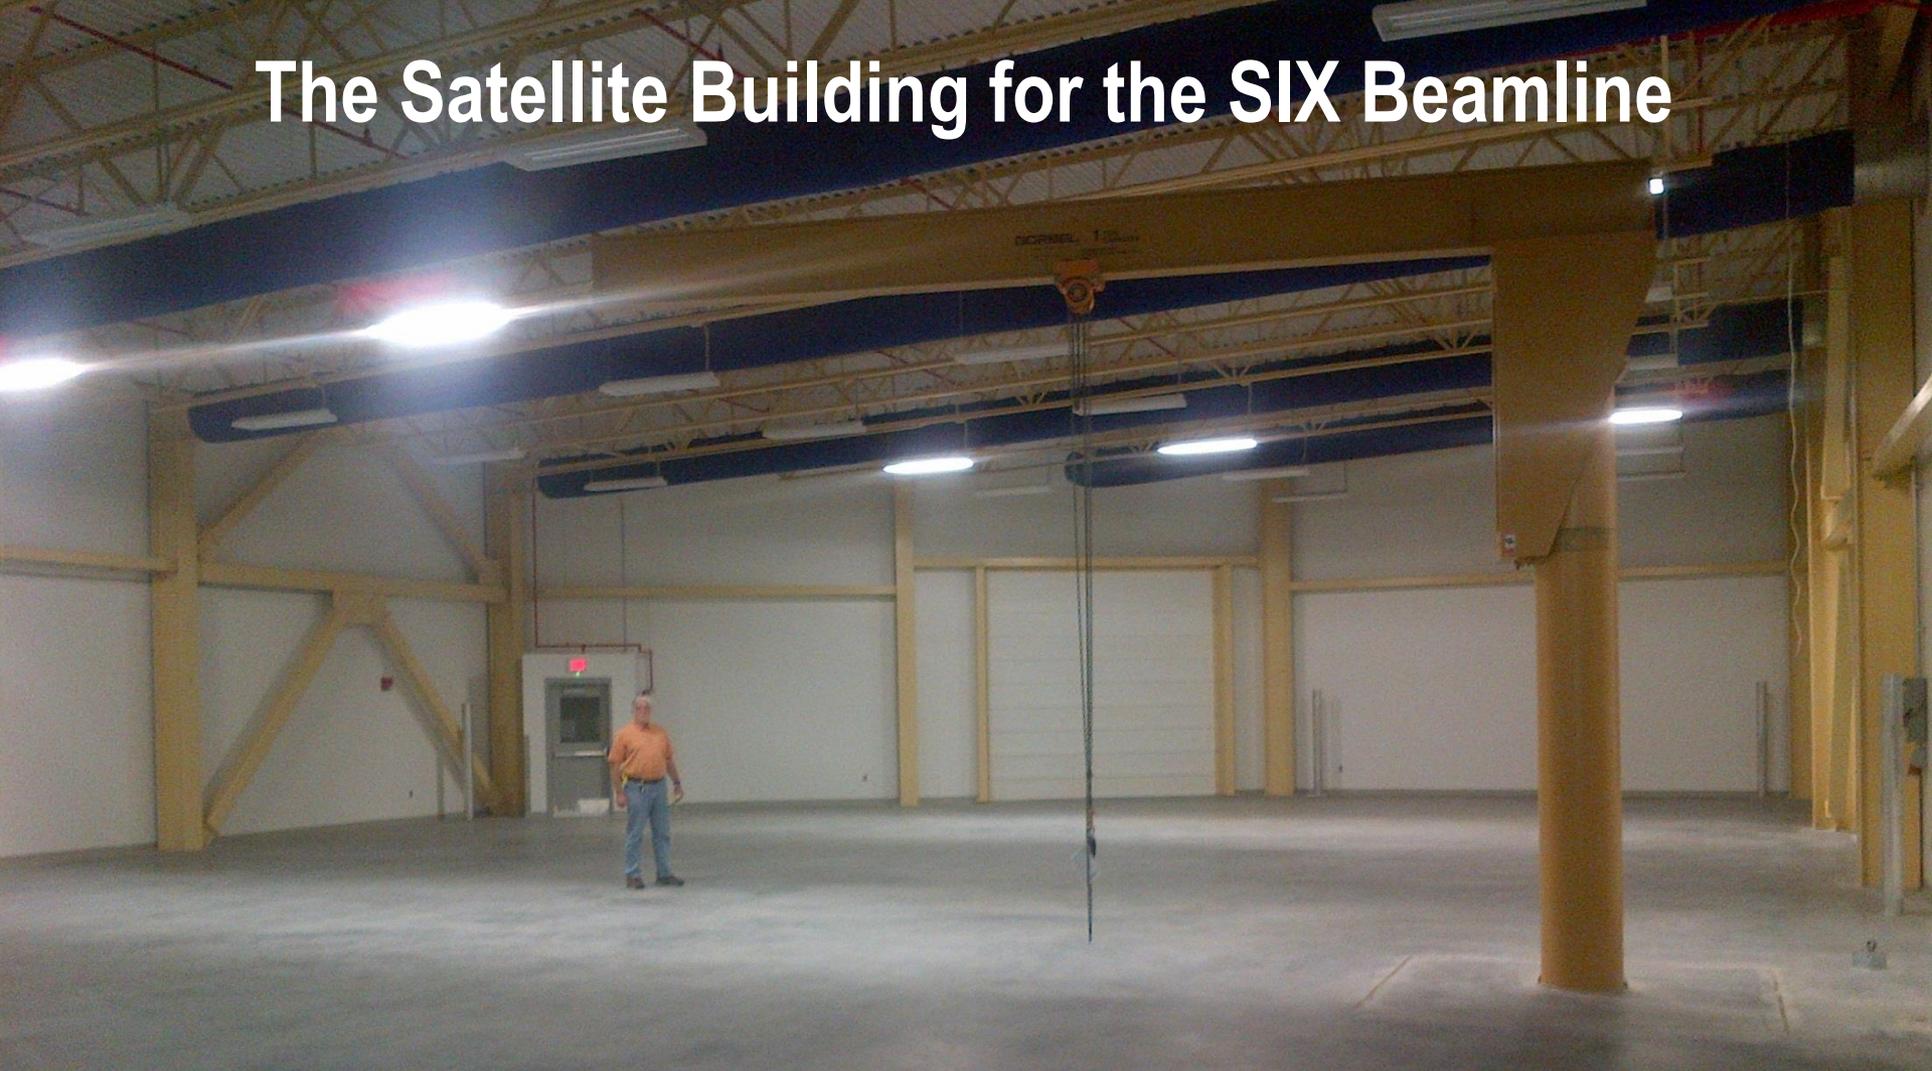
# The Satellite Building for the SIX Beamline

Low Thermal Mass and Very Large.

High Temperature Stability ( $\pm 0.01\text{C}$ ) Needed for Scientific Success ( $0.4\ \mu\text{m}$  stability at 4m height)

Sophisticated HVAC and control system – expensive and requires a lot of time to optimize  
– gives excellent performance ( $\pm 0.025\text{C}$ ), but we need to do better.

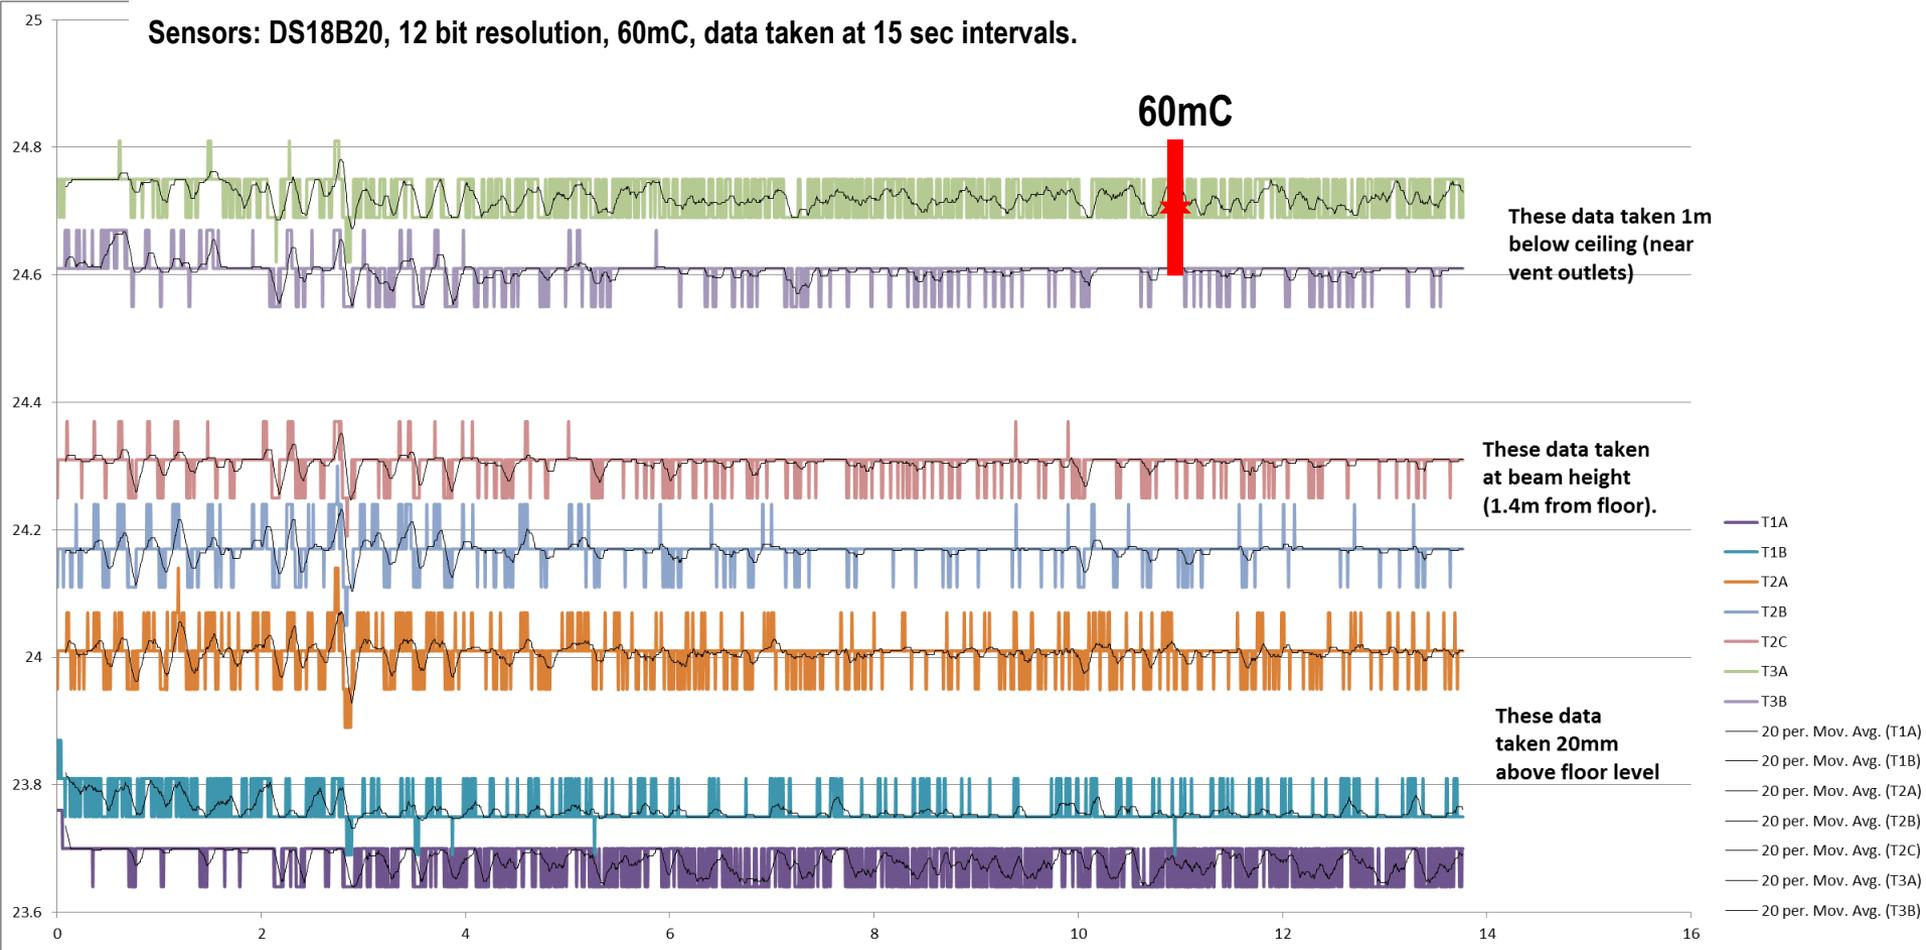
# Temperature Stability over 12 hours after Closing Door of SIX Satellite Building

Note: absolute values of data adjusted for clarity. Stability  $\sim\pm 0.025\text{C}$  with 5 minute moving average and sensors in free air.

Sensors: DS18B20, 12 bit resolution, 60mC, data taken at 15 sec intervals.

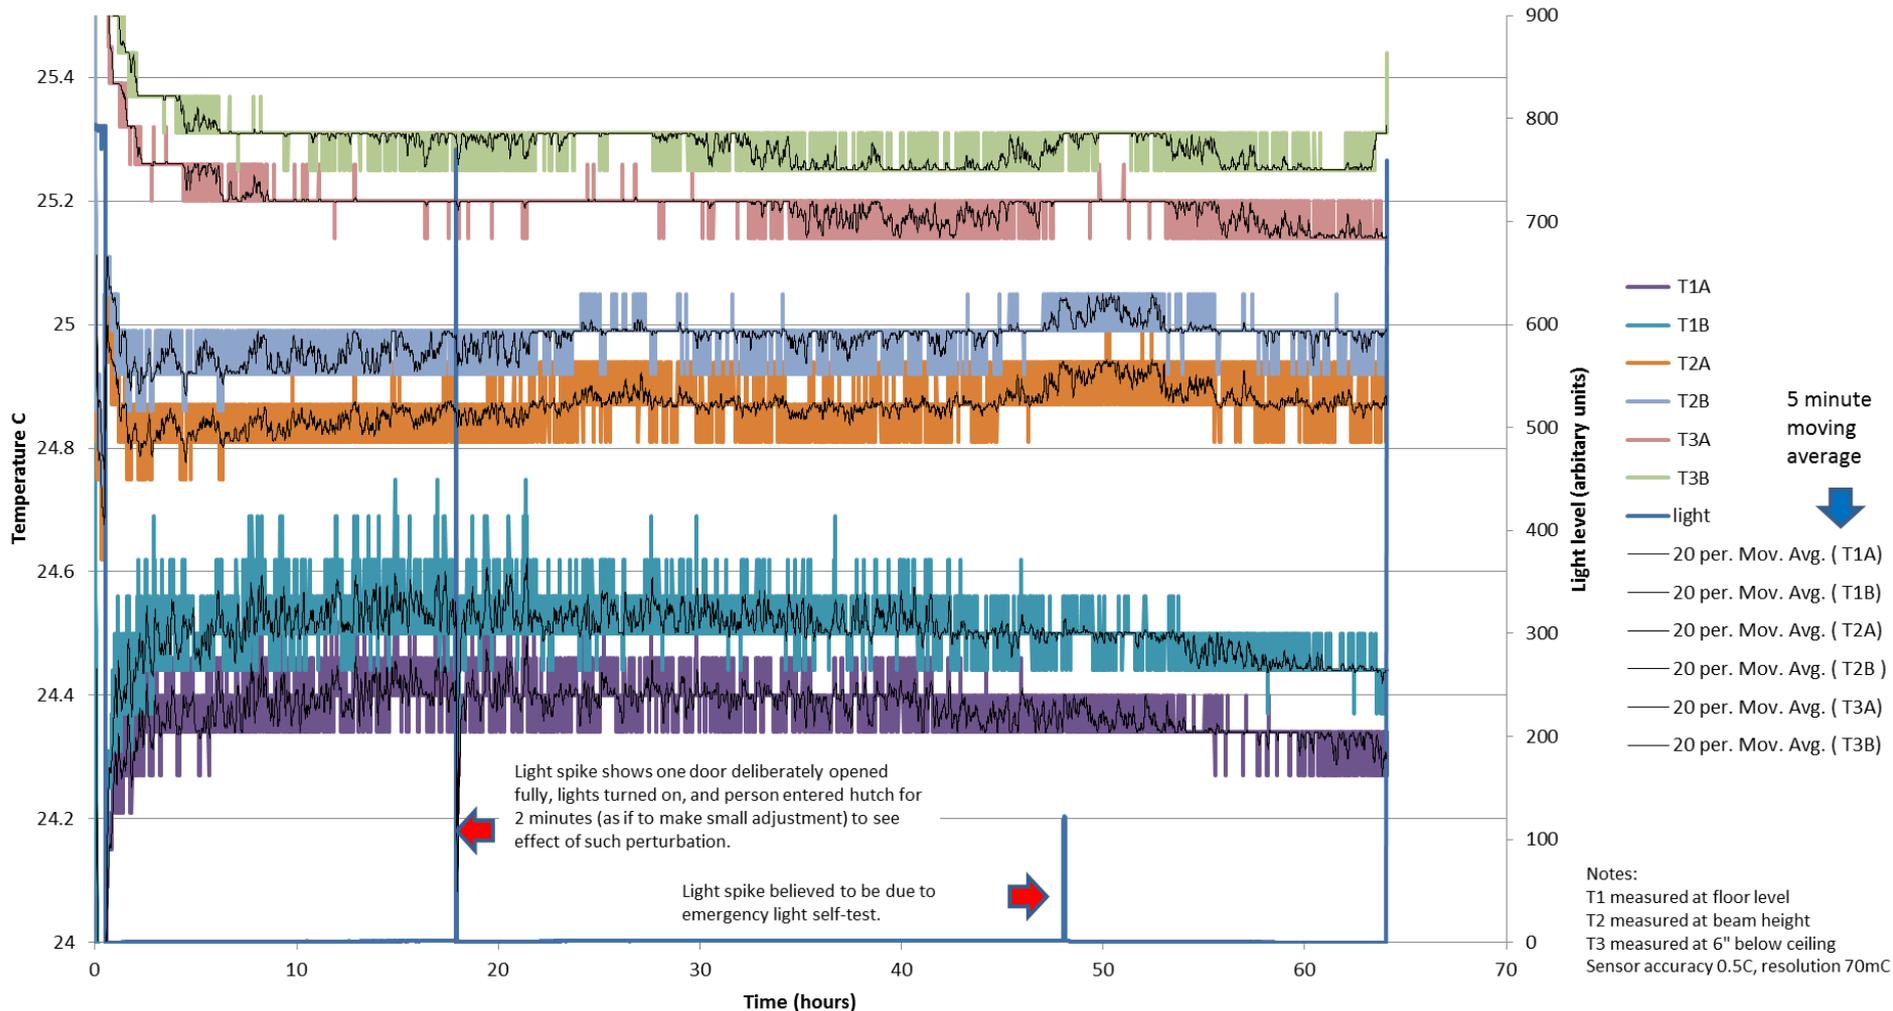
# Temperature Stability over Several Days in a Typical FOE (no special precautions taken)

Note: absolute values of data adjusted for clarity. Stability  $\sim \pm 0.06\text{C}$  with 5 minute moving average.

Temperature logged at 15s intervals in CSX FOE 23-ID-A, electronics connected, water flowing (29.5C), doors closed (except when light level spiked), ventilation fan on.

Location	Stability	Notes
On Experimental Floor	+/-0.3C	
In End Station	+/-0.25C	Very large steel hutch, slightly better data: (+/-0.2C) for smaller hutch.
In First Optics Enclosure	~+/-0.06C	Lead hutch attached to 1m thick concrete ratchet wall with +/-0.1C stability on other side.
Satellite building (HXN)	<+/-0.05C	20m x 5m concrete hutch with HVAC taken from adjacent Lab-Office Building.
Satellite building (SIX)	+/-0.025C	Very large volume, expensive and sophisticated HVAC system and controls.
