# The Quest for Stability at NSLS-II

Andy Broadbent with acknowledgements to many staff at NSLS-II and especially Yong Chu (HXN beamline group leader) and Nick Simos (vibration engineer).

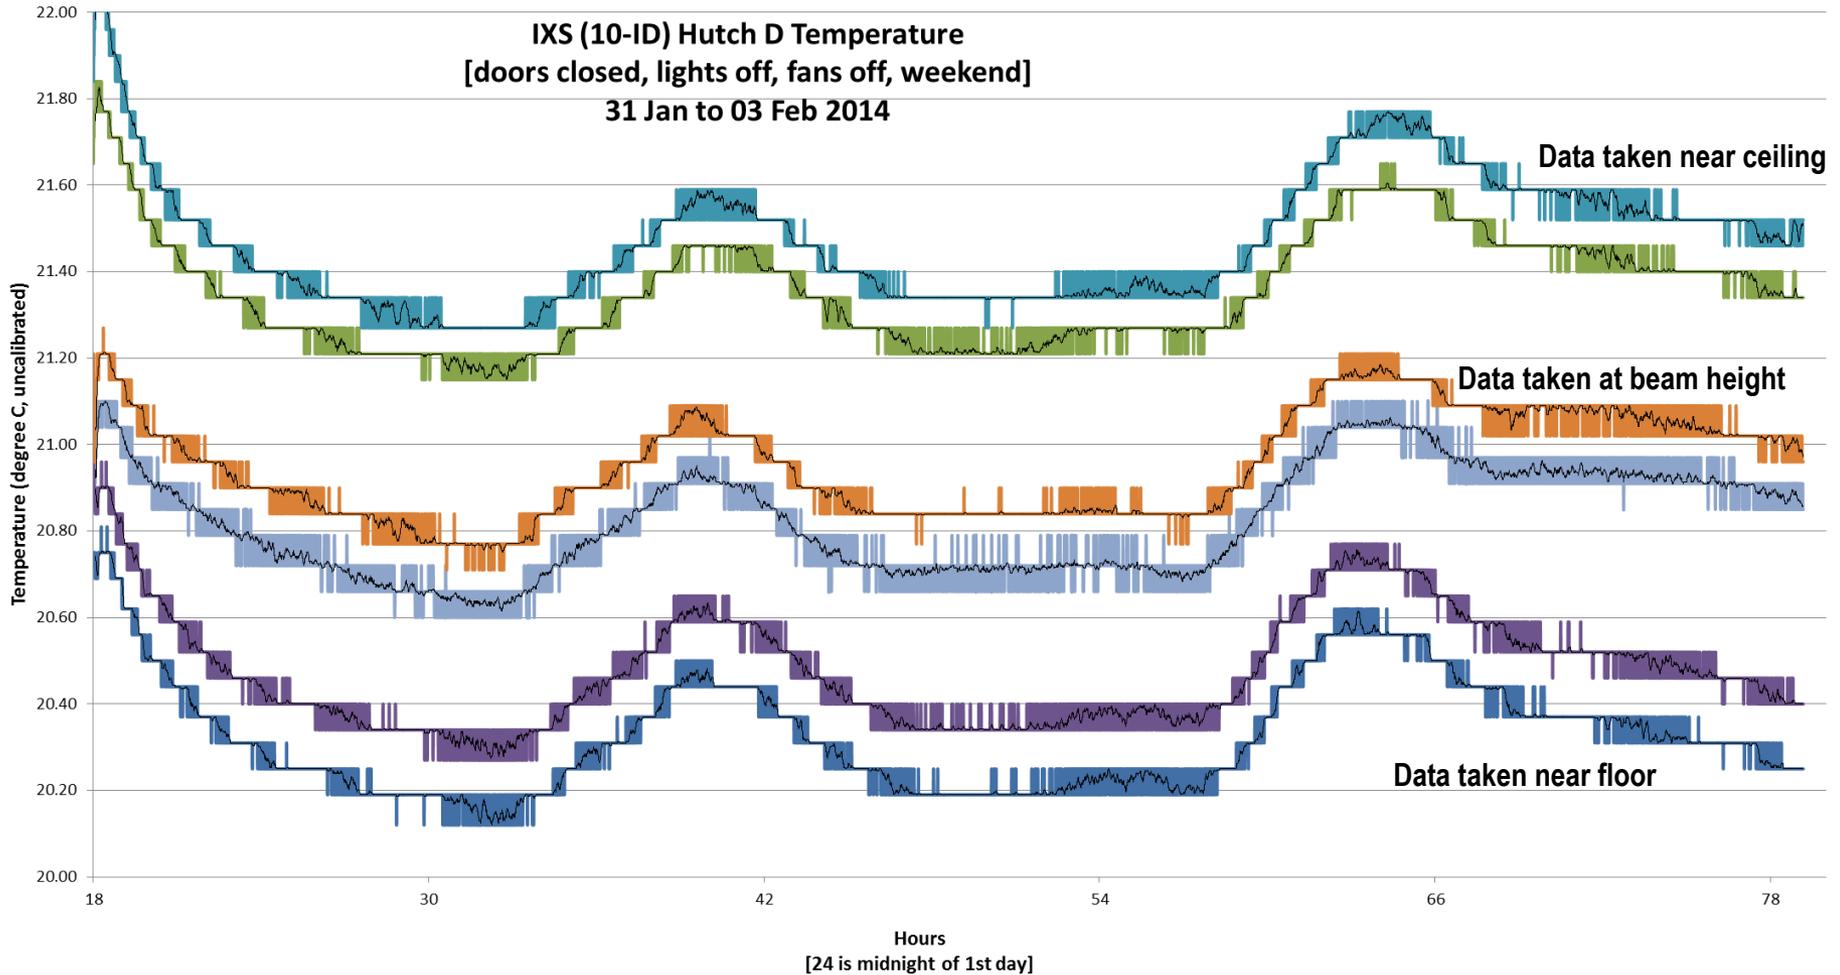
# Temperature Stability over Several Days in a Large Steel Experimental Station

Note: absolute values of data adjusted for clarity. Stability  $\sim \pm 0.25\text{C}$  with 5 minute moving average.

Location	Stability	Notes
On Experimental Floor	+/-0.3C	
In End Station	+/-0.25C	Very large steel hutch, slightly better data: (+/-0.2C) for smaller hutch.
In First Optics Enclosure	~+/-0.06C	Lead hutch attached to 1m thick concrete ratchet wall with +/-0.1C stability on other side.
Satellite building (HXN)	<+/-0.05C	20m x 5m concrete hutch with HVAC taken from adjacent Lab-Office Building.
Satellite building (SIX)	+/-0.025C	Very large volume, expensive and sophisticated HVAC system and controls.
